**AN5116-06B**

**Optical Line Terminal Equipment**

**Alarm and Event Reference**

**FiberHome Telecommunication Technologies Co., Ltd.**

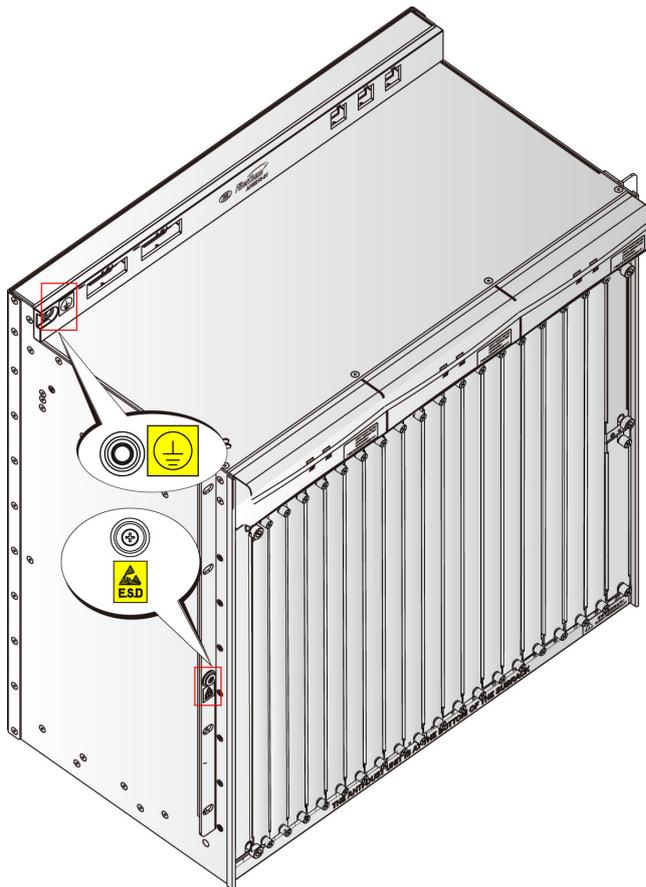
Figure 1-1 Positions of the ESD protection earth ground fastener, subrack earth ground pole

The following uses the subrack as an example to introduce the locations of the ESD protection sign and the subrack earth ground sign.

The ESD protection sign. This sign reminds the operators to wear an ESD protection wrist strap, so as to avoid damage to the equipment caused by electrostatic discharge.	See Figure 1-1.

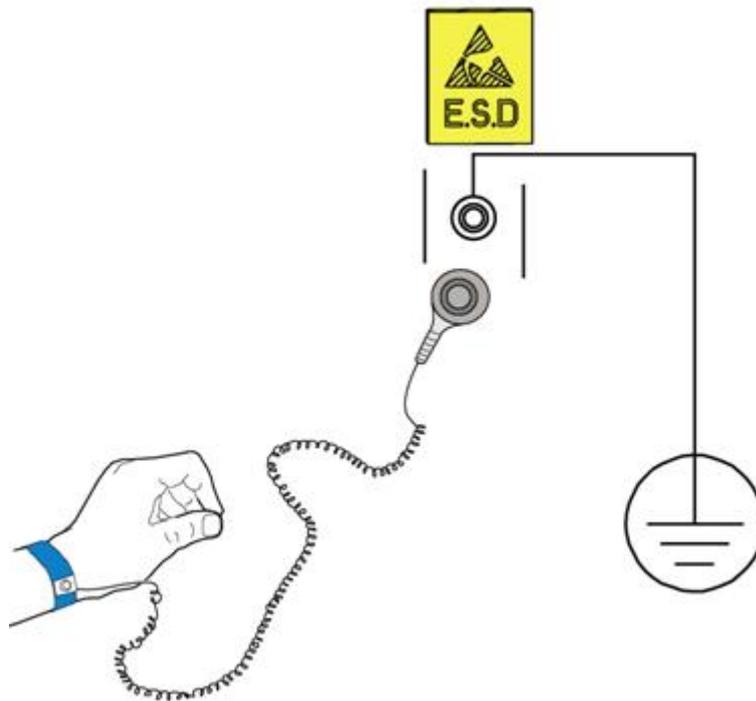
Figure 1-2 Wearing the ESD protection wrist strap

The ESD protection wrist strap is an accessory shipped with the equipment. Make sure that the metal fastener of ESD protection wrist strap is in good contact with the skin and the other end of wrist strap is correctly connected to the ESD protection earth ground fastener on the cabinet, as shown in Figure 1-2.

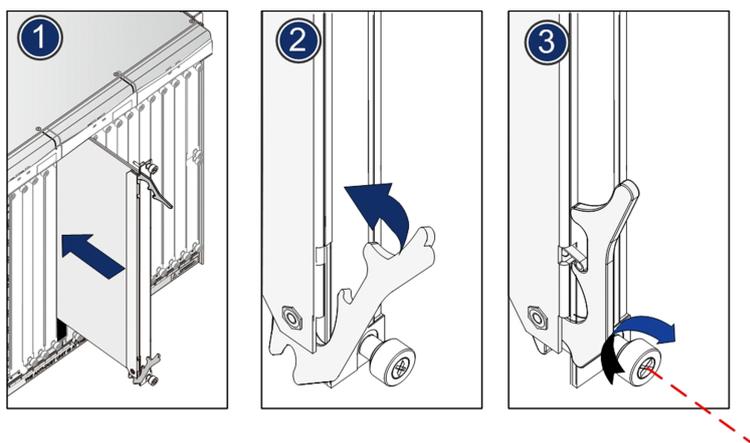
Figure 1-3 Installing a card

- ◆ Before plugging the card, you should confirm:
  - ▶ The corresponding slot is available.
  - ▶ Cables or optical fibers are not connected with the card.
  - ▶ The insertion direction of the card. Do not insert the card in the opposite direction. The insertion direction of the card is shown in Figure 1-3.
- ◆ Pay attention to the following precautions when plugging the card.
  - ▶ Use care when plugging the card to avoid distorting pins on the backplane.
  - ▶ Slide the card gently along the slide rails. Prevent the circuit components of the card from contacting each other, to avoid shorting or scratching. See Figure 1-3 for the card installation.
- ◆ Before unplugging the card, confirm the card is not carrying services. Unplugging the in-service card may cause service interruption.

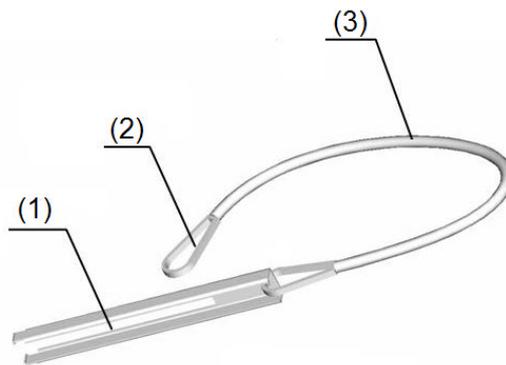
Figure 1-4 The dedicated fiber puller

The fiber puller is the delivery accessory and looks like a nipper and has a spring cord, as shown in Figure 1-4.

The fiber puller is secured on the cabinet with a spring cord before delivery. By clipping the fiber connector with the special fiber puller, you can plug or unplug the fiber very conveniently.

(1) Fiber puller

(2) Buckle (Buckle it into the mounting hole on the vertical mounting flange)

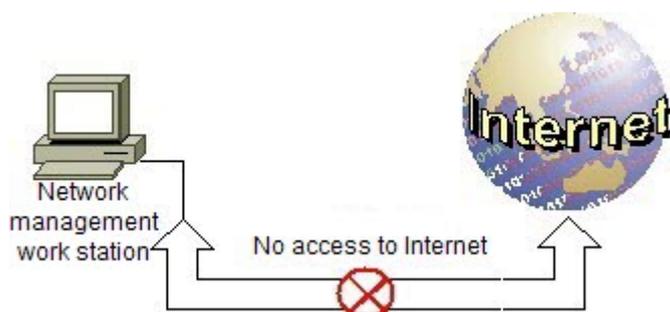
Figure 1-5 No access to Internet

- ◆ Do not delete any file in the network management system randomly or copy any irrelevant file into the network management computer.
- ◆ Do not visit Internet via the network management computer. Doing so may increase data flow in the net card and hence affects normal network management data transmission or results in other accidents.

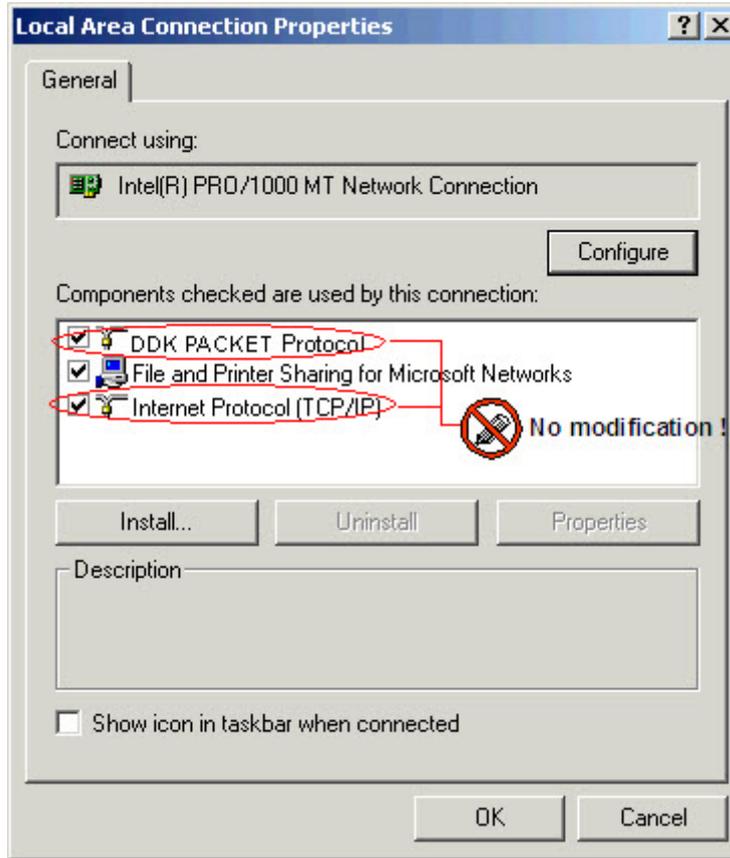
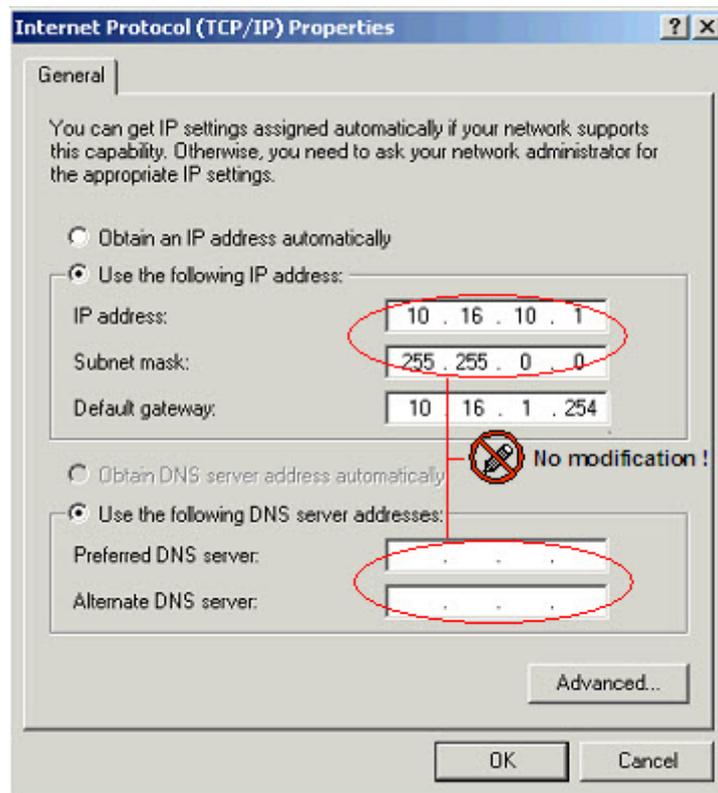
- ◆ Do not perform service configuration or expansion during service busy hours via the network management system.
- ◆ Do not modify the network management computer's protocol settings, computer name or LAN settings. Doing so may result in abnormal operation of network management system

Figure 1-6 Do not modify protocol settings (1)

Figure 1-7 Do not modify protocol settings (2)
